## Proposal on the Belt Conveyor Roller

**TOUWA Industries CO.,LTD**

**HAGIO High Pressure Containers CO.,LTD**

# History of the development of the Belt Conveyor Roller

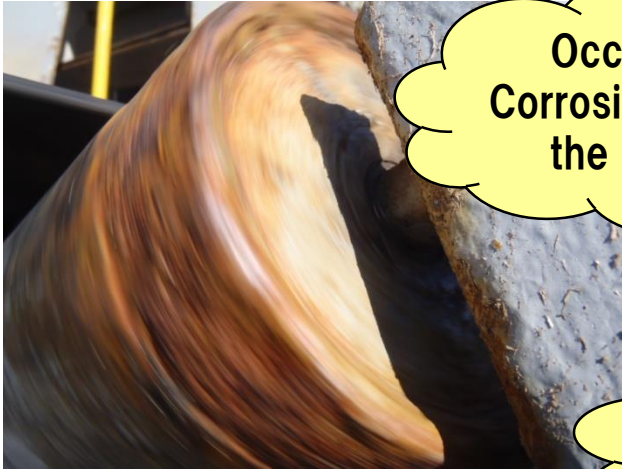
Occurring  
Corrosion inside  
the Roller

- Increase and Decrease of the temperature and pressure inside the Roller due to the rotation and stopping of the Roller
- Corrosion due to the atmosphere containing saline vapor ⇒ Failure of BRG
- Stopping of rotation ⇒ Uneven wearing of the Roller ⇒ Failure of the Belt

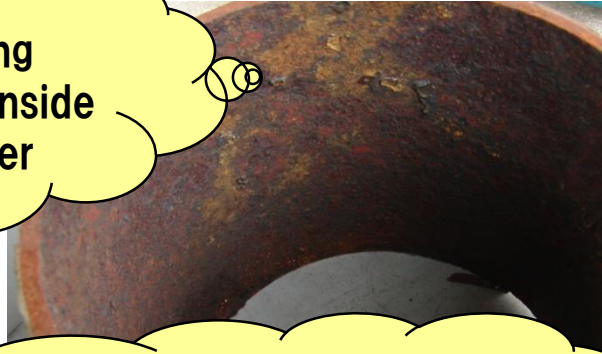
Bad sealing lead to the  
short life of the Roller,  
even after replacing BRG.

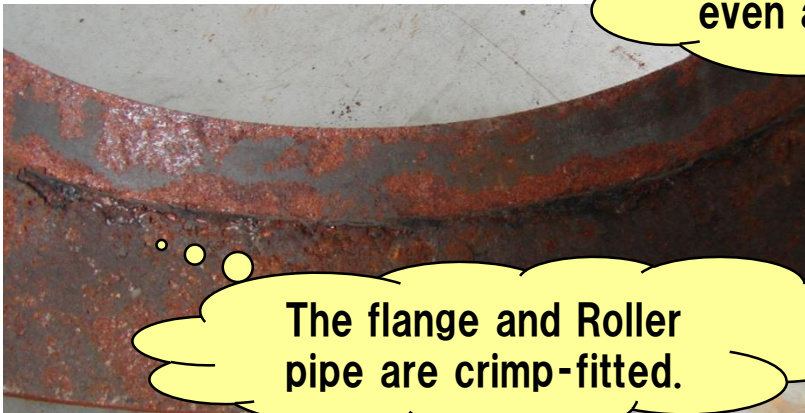
The flange and Roller  
pipe are crimp-fitted.

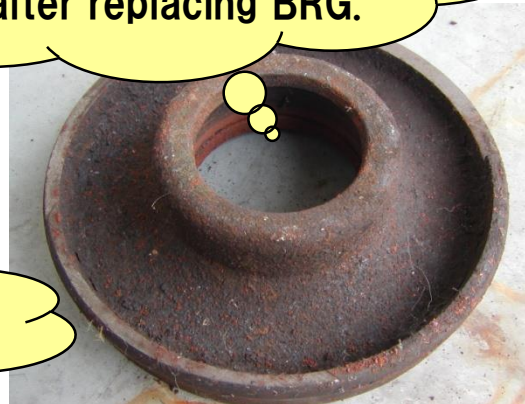
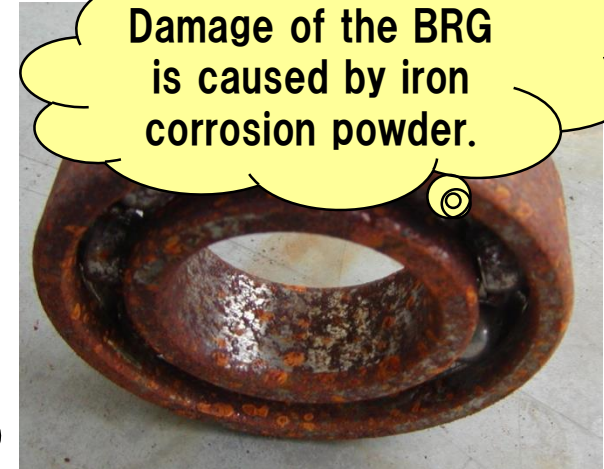
Damage of the BRG  
is caused by iron  
corrosion powder.

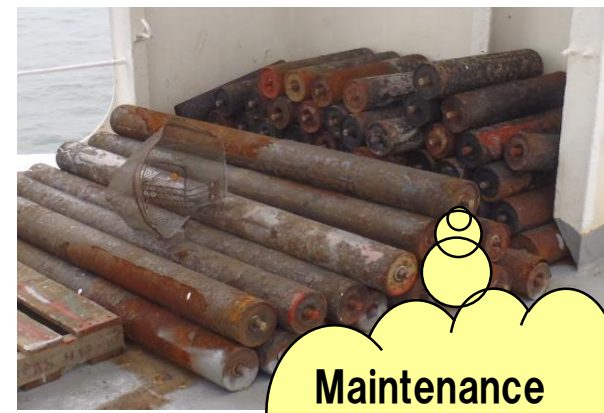
Maintenance  
is done by  
replacing  
whole Roller  
assembly.

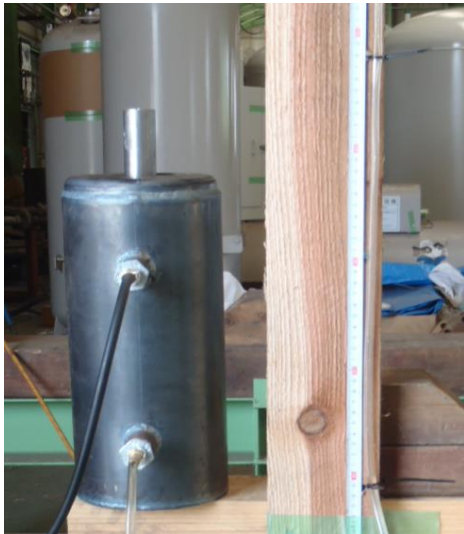
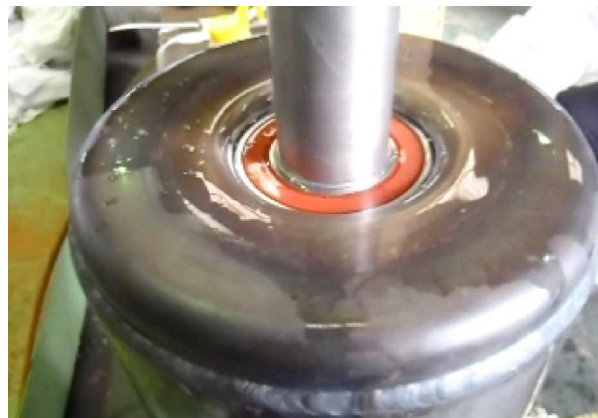
NO Leakage at the pressure difference of 5kPa.

[Between the outer ring of BRG: Flange] and [Between the inner ring and shaft]

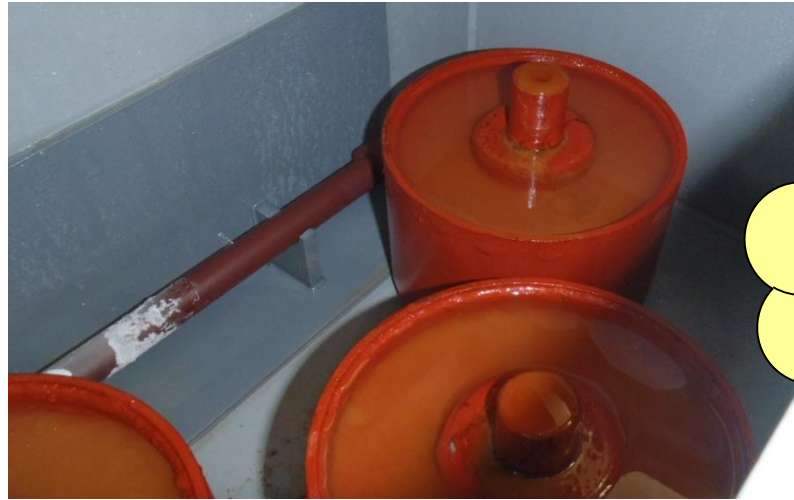
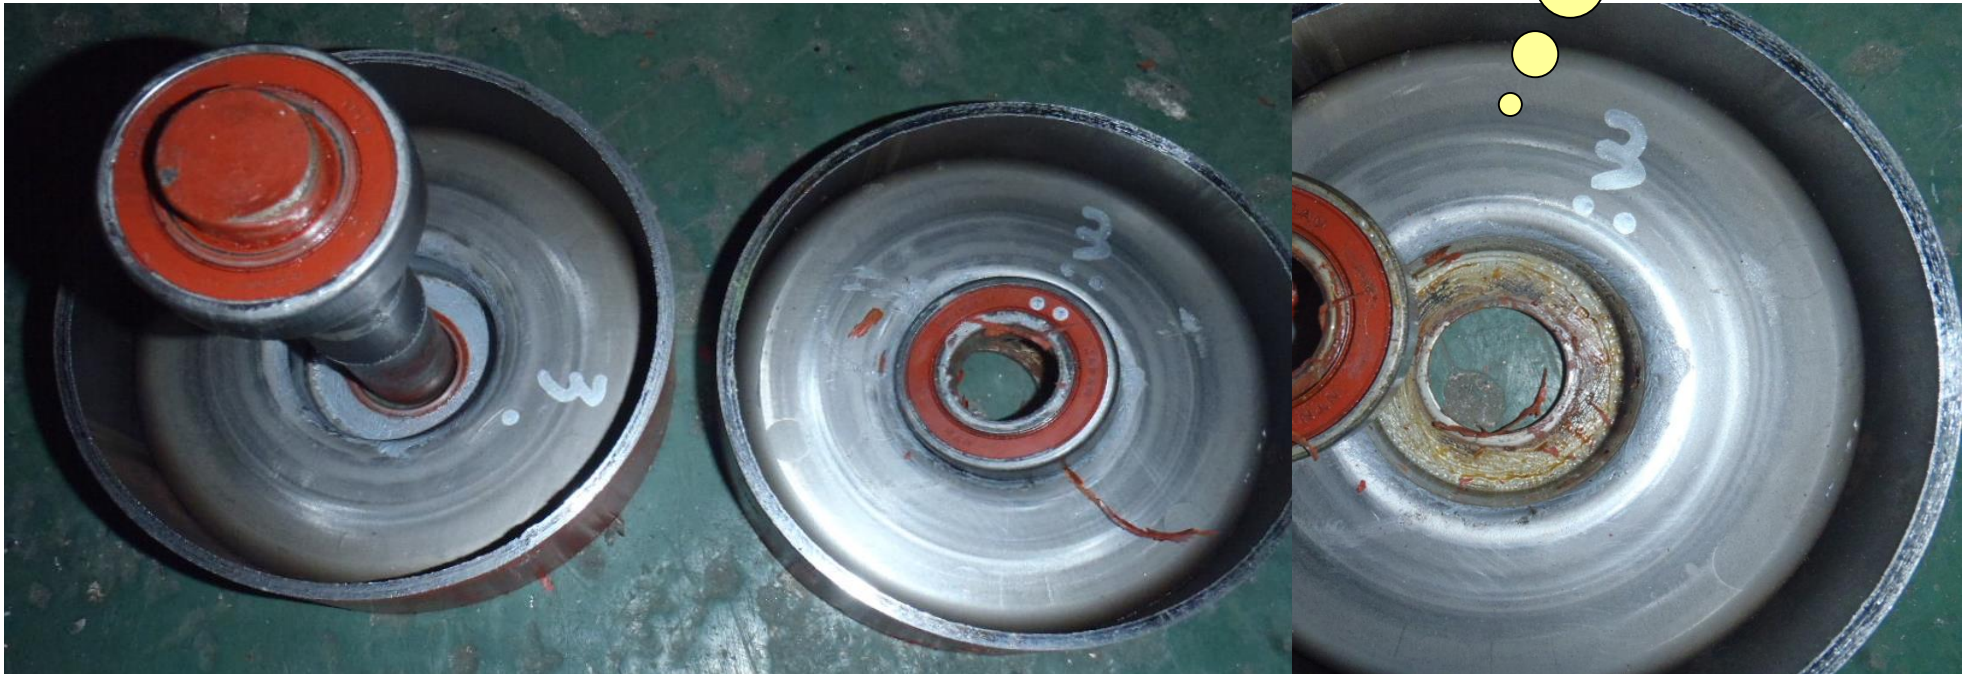
Intrusion of the saline water or occurrence of corrosion was not observed.

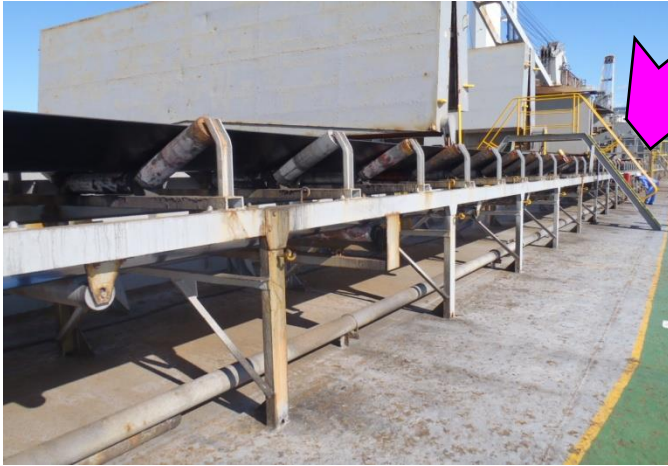
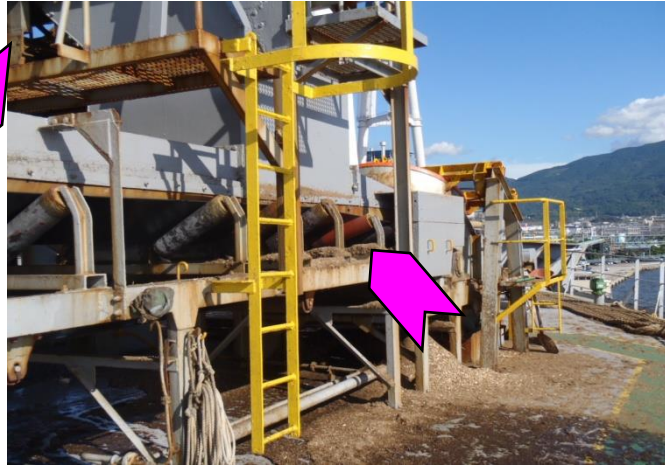
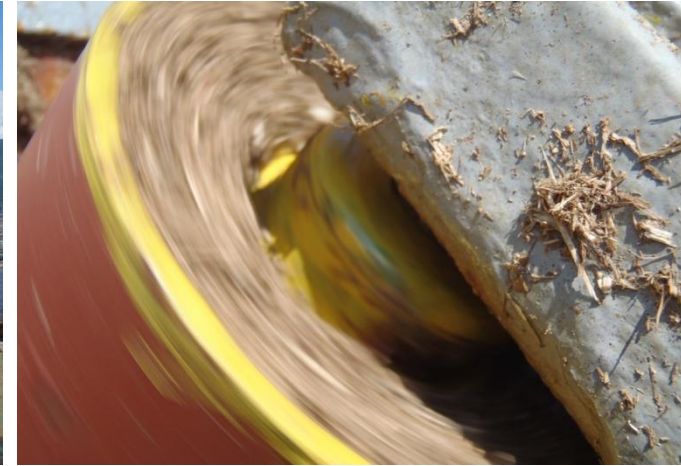
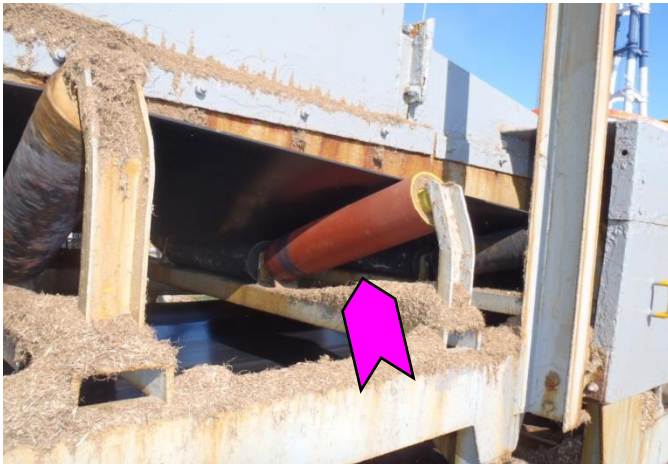
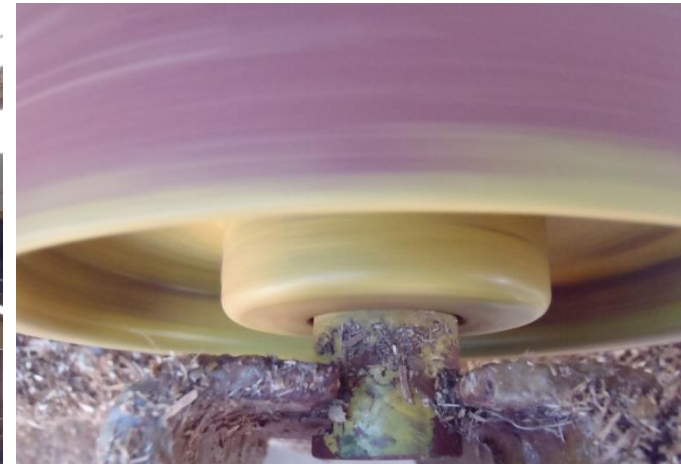
The newly developed Roller was mounted on the conveyor system of a ship (in the duration of 10 months). ⇒ The photos are the results after about 5 trips.

- NO Corrosion inside the Roller.
- NO Leakage of Grease through the BRG Sealing
- Smooth Running of the BRG with NO Problem
- NO Intrusion of Chip Powder inside the Roller

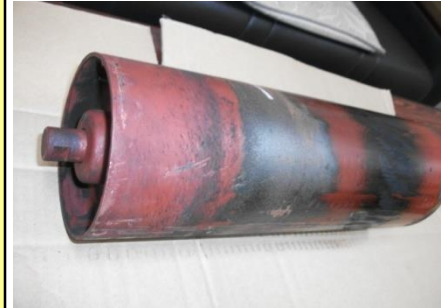
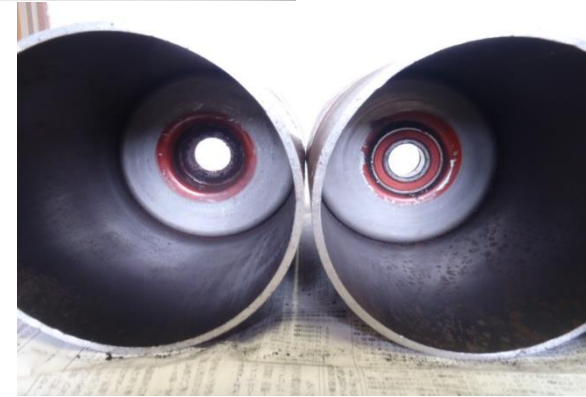
- The rotating conditions did not change from the new products. No Problem.
- Corrosion inside Rollers: No corrosion was observed expect for the initial corrosion of the material. No Problem.
- 66<sup>th</sup> Block is still running smoothly (2013/3).
